BAGHDAD AL KARKH
COURTHOUSE
BAGHDAD, IRAQ

SIGIR-PA-06-058
OCTOBER 10, 2006

SUBJECT: Report on Project Assessment of the New Al Karkh Courthouse,
Baghdad, Iraq (Report Number SIGIR-PA-06-058)

Baghdad Al Karkh Courthouse Baghdad, Iraq

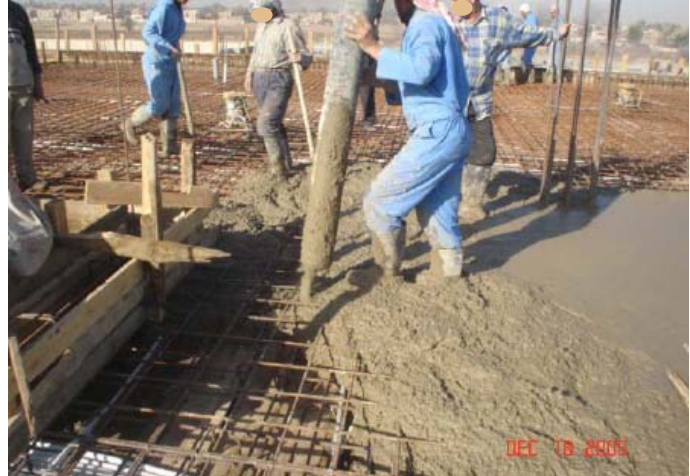
Site Photo 3. Concrete placement for roof slab pour (Photo provided by USACE)

In our review of the progress photos and QA reports we did not find any evidence of problems with the quality of the concrete, such as honeycombing, segregation, or exposed reinforcing steel. Additionally, our review of the QAR reports did not indicate any problems with the concrete achieving required compressive strengths.

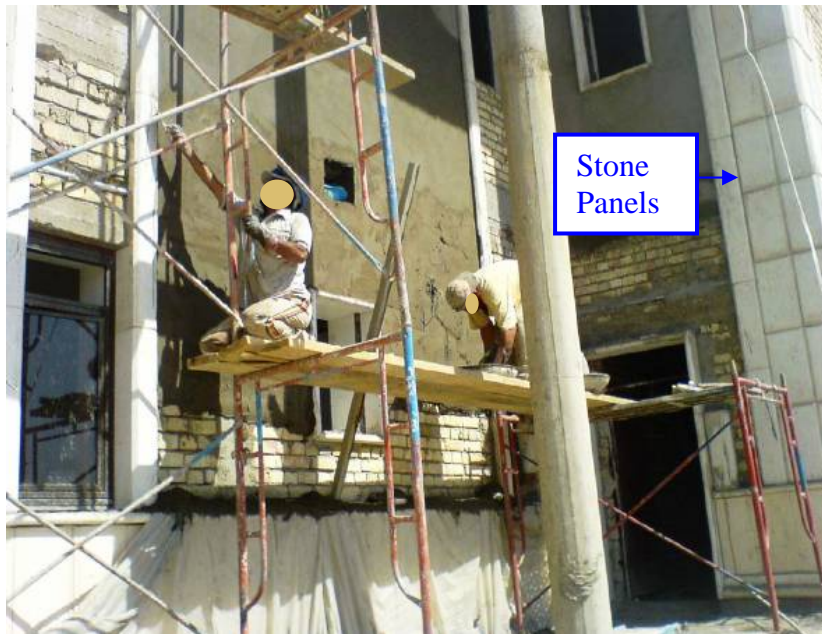
The design did not provide typical wall detail sections except for seven specific exterior wall locations on three detail sheets, which showed 25 cm thick brick walls. According to the DRE, the design originally called for the entire building exterior to be finished using stone panels. Instead, because of the stone panel shortage, only parts of the building's exterior (along the building corners, the parapet and window frames) would be clad with the stone panels. The remaining brick walls according to the DRE will be plastered and painted as shown in Site Photo 4. According to the most recent QA report, dated 3 July 2006, the outside finish work (stone panel application, plastering and painting) was in progress.

Site Photo 4. Plastering exterior wall between windows (Photo provided by USACE)

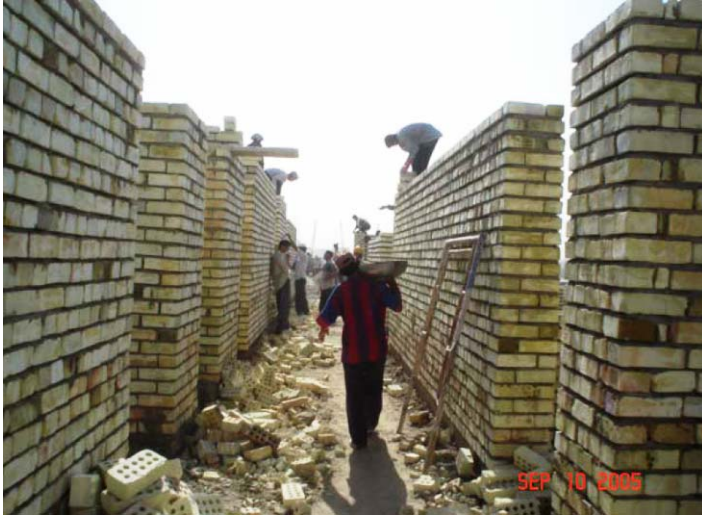
In discussions with the USACE DRE and review of the QA reports, we established the brick walls serving as load bearing walls on the ground floor were 36 cm thick. The design did not include detail sections showing 36 cm walls, but in the floor plan views for the ground and the first floor, the locations of the 36 cm walls were shown, as well as the 25 cm walls. On the first floor, the QA reports document the contractor constructing 24 cm walls² on some parts of the first floor, and 36 cm load bearing walls in others. Site Photos 5 and 6 provide examples of the 36 cm interior wall construction and the 24 cm interior wall construction.

**Site Photo 5. 36 cm walls on ground floor
(Photo provided by USACE)**

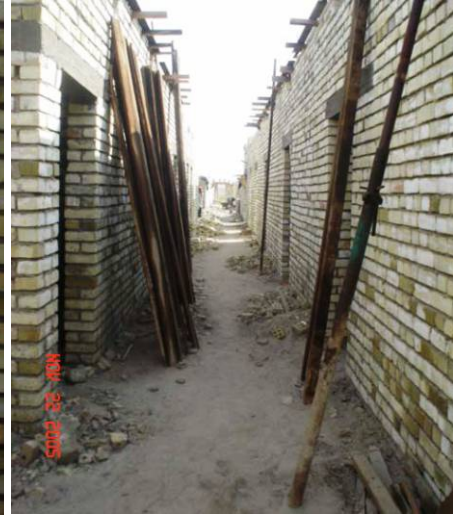
Site Photo 6. 24 cm walls on ground floor (Photo provided by USACE)

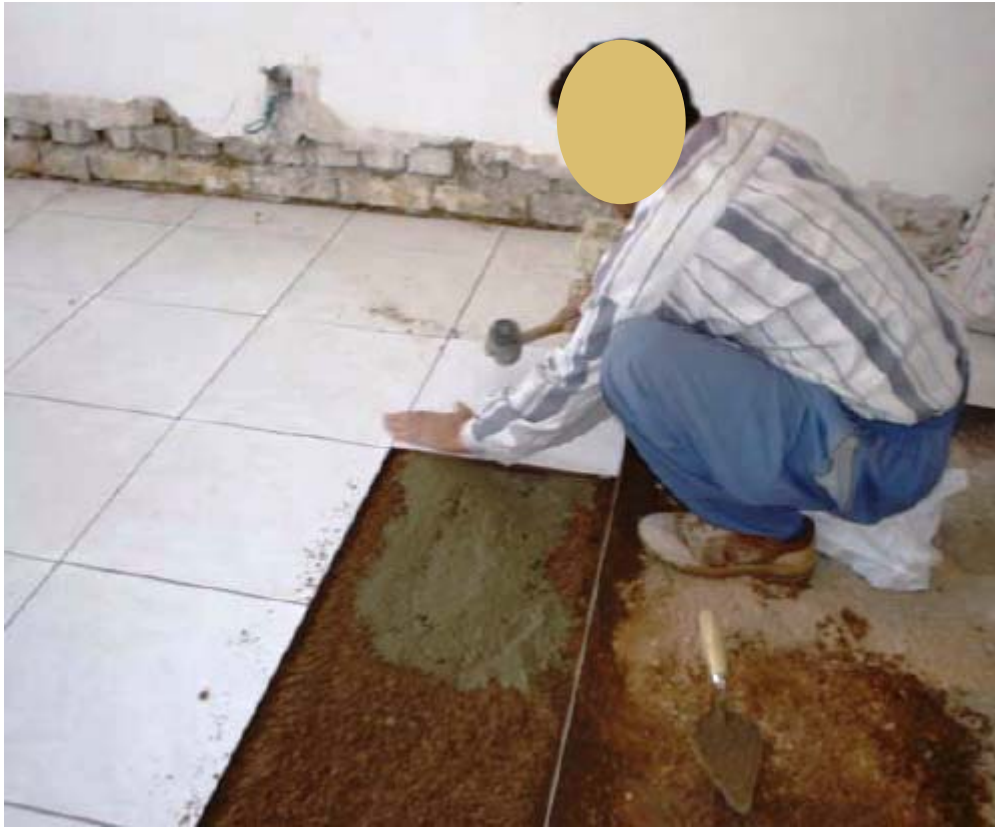
The design included finish schedules providing the required ceiling, wall, and floor finish for each courthouse room. The finish schedule required ceramic tile floors throughout the courthouse. The progress photos and QA reports indicate the ceramic tile was placed over the concrete slab using a sand and cement mix as shown in Site Photo 7. Based on this photo as well as the others reviewed by the assessment team, it appears the sand was spread to a certain thickness on the concrete floor slab. Next, a cement slurry was added to the top of the sand to provide a bonding surface for the tile. However, the cement slurry has not been mixed with the sand and does not provide a bond to the concrete substrate. This is regarded as standard construction practice in Iraq for laying ceramic tile. The sand is utilized for leveling and the cement provides the bond between tiles. Although there were significant requirements for ceramic tile throughout the courthouse, our review of the progress photos and QA reports indicated the ceramic tile installation was accomplished without deficiencies noted by the QAR.

Site Photo 7. Laying ceramic tile (Photo provided by USACE)

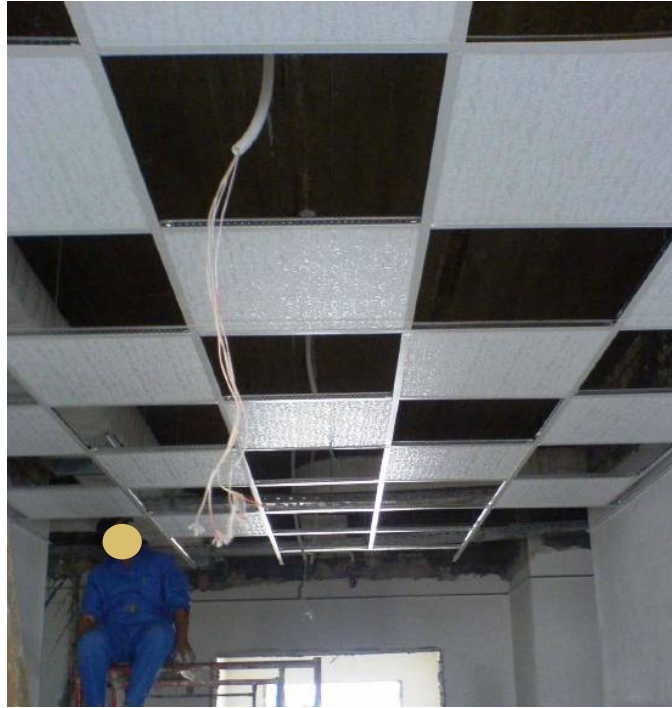
The room finish schedules also required painted ceilings or suspended ceilings. The design shows suspended ceilings in the hallways, lobby areas, and some of the bathrooms. Site Photo 8 provides an example of the suspended ceiling construction using gypsum ceiling tiles. The other type of suspended ceiling involved hanging a metal frame, then attaching a wire mesh lath to act as a plaster base. The ceiling was then plastered and painted. The QA reports indicate there were no deficiencies associated with either type of suspended ceiling installation or the plastering and painting of walls and ceilings.

Site Photo 8. Suspended ceiling and tile installation (Photo provided by USACE)

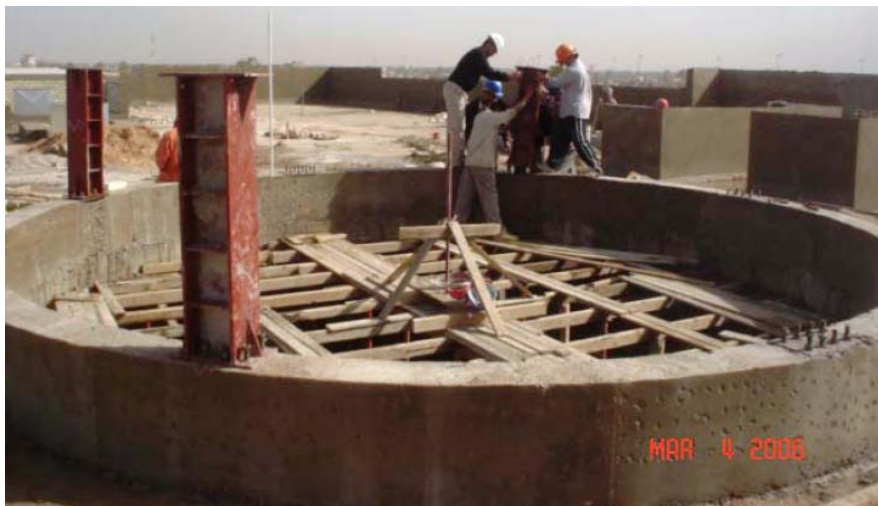
Site Photo 9. H-Columns anchored to dome concrete base (Photo provided by USACE)

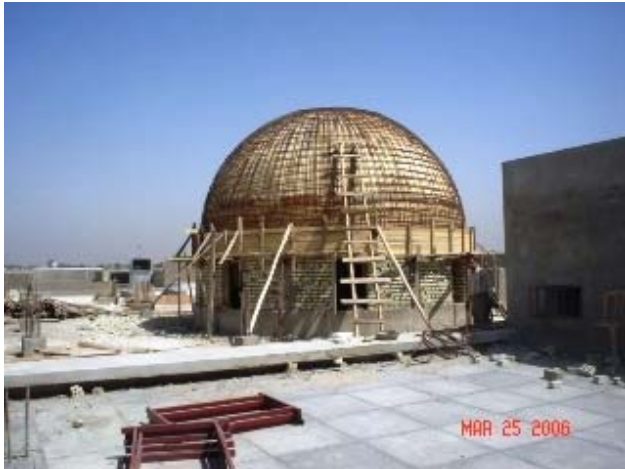
Site Photo 10. Dome after reinforcing steel installation (Photo provided by USACE)

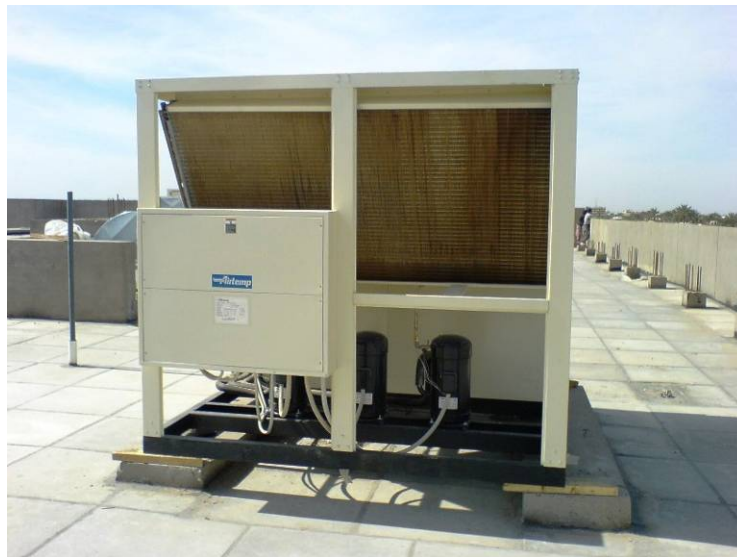
The design required 15 roof top HVAC units with a total cooling capacity of 795,000 BTU/hour or 66.25 tons. Site Photo 12 shows one of the roof top units. The progress photos indicate two types of HVAC units were installed, an Airtemp Model 530 and an Airtemp Model 415. We were not provided with the manufacturer's catalog information showing the cooling specifications of each type of unit installed; therefore, we could not verify if the units met the requirements of the design.

Site Photo 12. Roof top HVAC unit (Photo provided by USACE)

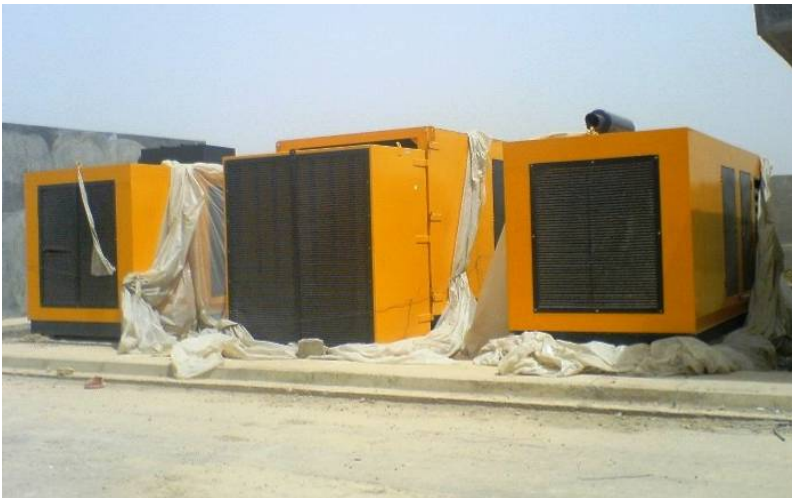
The design required two outdoor electrical generators to meet the courthouse electrical demand and the electrical requirements of the other buildings contained in the task order (cafeteria, kiosks, check points, bathrooms, etc.). The design called for two generators, a 1,000 kilo-volt amp (KVA) unit and a 650 KVA unit. According to the USACE DRE, two generators were installed, a 1,000 KVA unit for the courthouse including its HVAC requirements, and a 630 KVA unit for the courthouse and the other buildings. They also indicated a third generator (350 KVA) was installed for the annex building. Site Photo 13 shows the three generator enclosures after delivery to the generator pad site. Site Photo 14 provides an illustration of one of the generators installed. The QA reports and progress photos do not indicate the manufacturer of the generators or their electrical capacity. In addition to the generators, two fuel tanks were also installed as well as the piping, valves, and fittings. As noted earlier in the assessment team's design and specifications review, there were no drawings providing details on the generator and fuel tank installation.

**Site Photo 13. Generators for the courthouse (2) and the annex (1)
(Photo provided by USACE)**

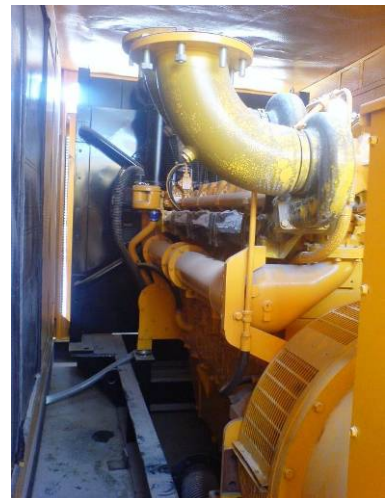
**Site Photo 14. Interior of the
generator enclosure
(Photo provided by USACE)**

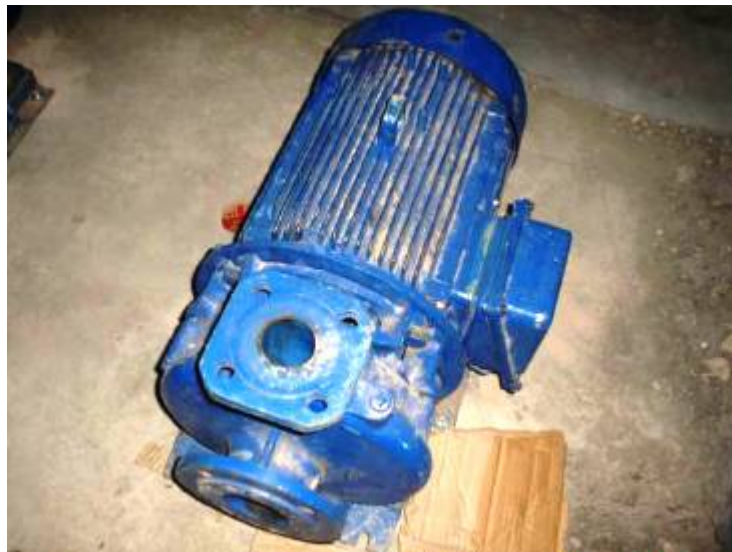
The design required four water circulation pumps, three for domestic water and one for the fire hydrant system. The capacity of the pumps according to the design was 18 m³/hour (hr) at 25 m head for the domestic water pumps and 18 m³/hr at 25 m head for the fire hydrant system pump. The contractor supplied and installed four circulation pumps. The pumps, based on our review of the QA report photos, do not appear new. We observed photos showing rust and dirt on the pump and motor housings. Site Photo 15 shows the condition of one of the pumps. In addition, the face plate on the fire hydrant pump system appears to have been altered because there are scratches in the entries for flow capacity.

Site Photo 15. Domestic water circulation pump (Photo provided by USACE)

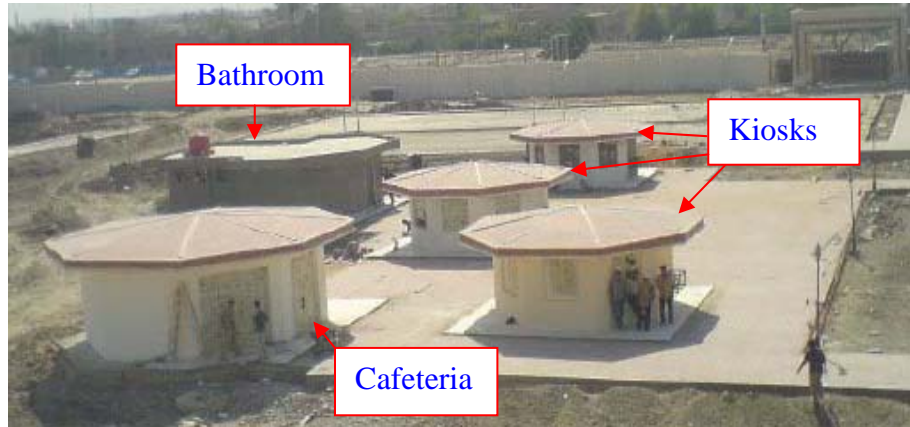
We could not verify the final finishes of each of the three building types. However, according to the 3 July 2006 QA report, the bathrooms, cafeterias, and kiosks were reported by the USACE QAR as 95% complete. The walls were plastered and painting was in progress. Site Photo 17 shows the nearly completed buildings. The QA reports do not indicate any problems associated with their construction.

Site Photo 17. Kiosks, bathroom, and cafeteria buildings (Photo provided by USACE)

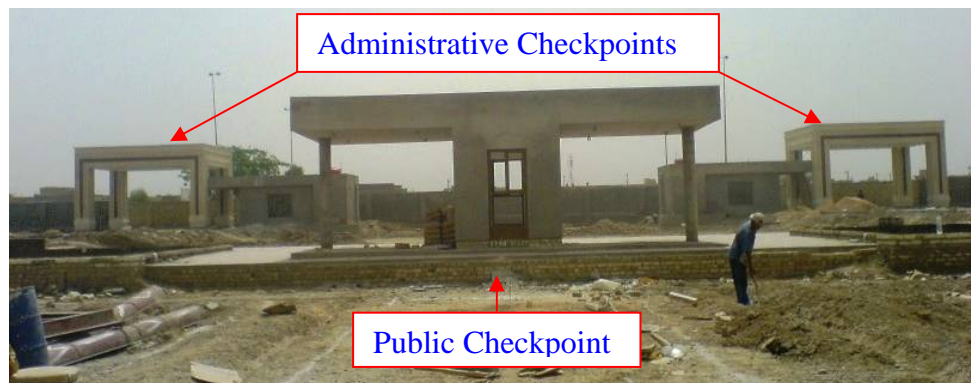
Site Photo 18. Administrative and public checkpoints (Photo provided by USACE)

Based on our review of the QA reports, there were no reported deficiencies associated with the checkpoints' construction. The 3 July 2006 report lists the three checkpoints shown in Site Photo 18 as 95% complete.

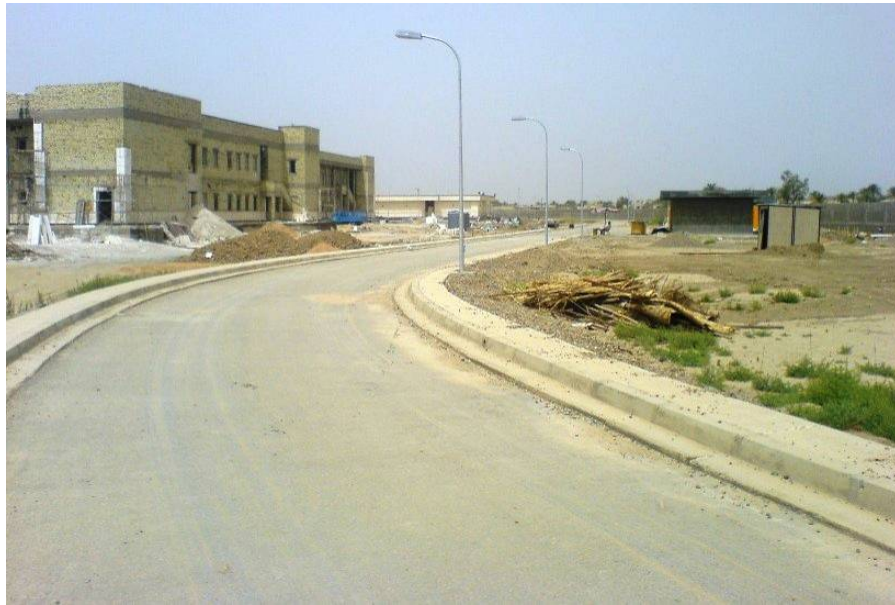
construction traffic. We found no reported deficiencies regarding the road and parking lot construction in our review of the QA reports and progress photos.

**Site Photo 19. Asphalt concrete base course with concrete curb and gutter
(Photo provided by USACE).**

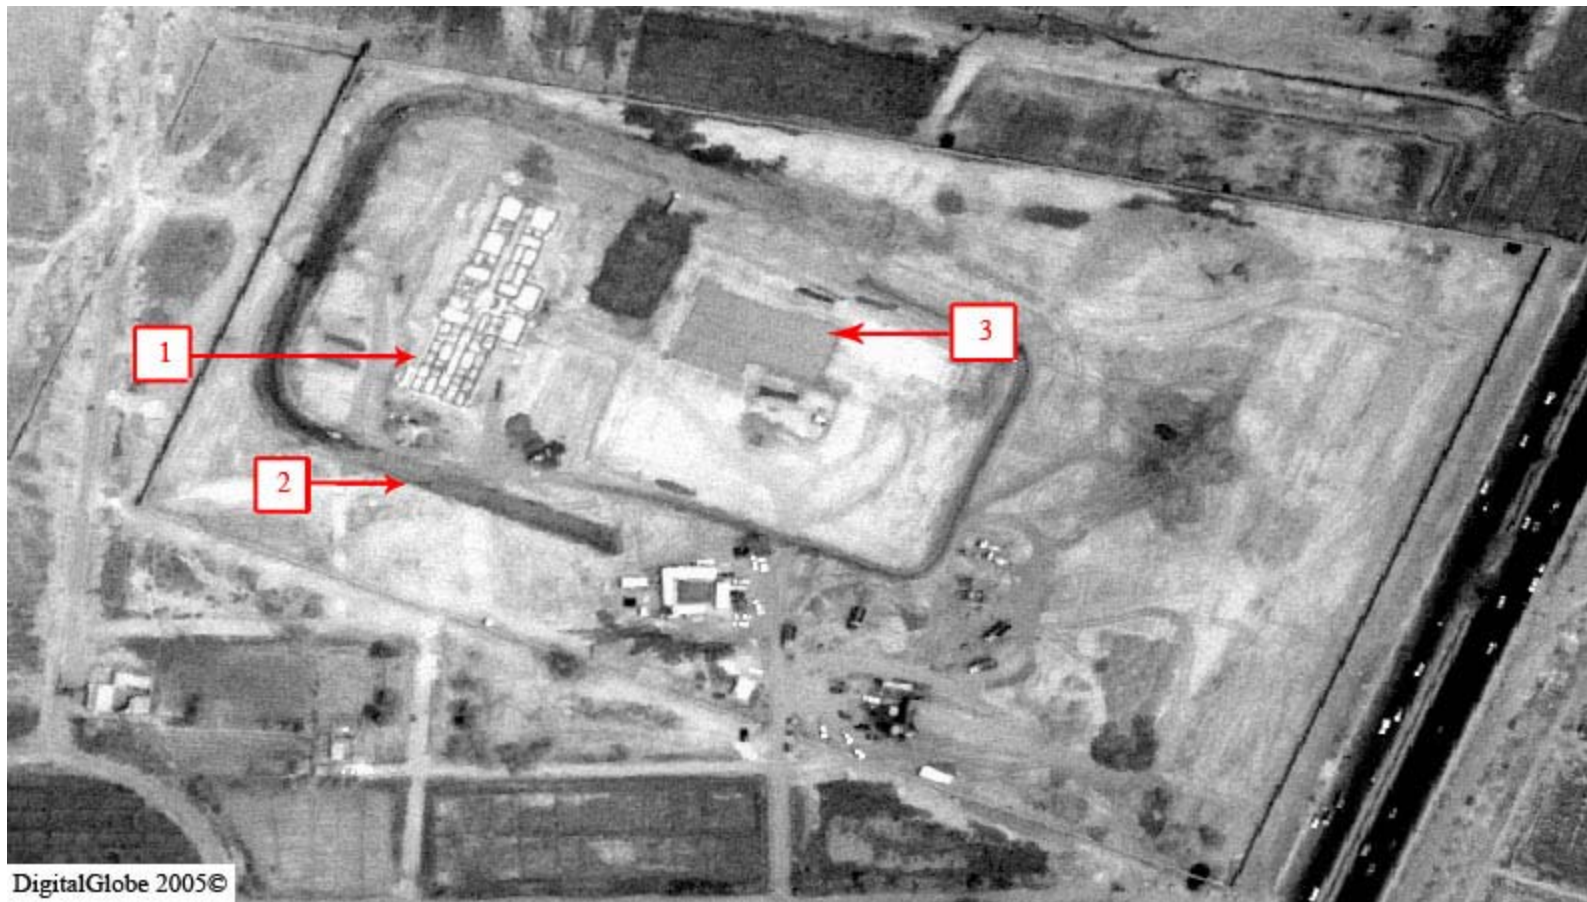
Since the assessment team was not able to travel to the site, we reviewed commercially available satellite imagery of the courthouse site to independently verify the construction progress. Aerial Image 1 shows the site on 10 August 2005 in the initial stages of construction. Item 1 is the annex building under construction. Item 2 is the road during the early stages of construction. Item 3 is the courthouse site. The darker area depicts the reinforcing steel placement for the raft foundation.

Aerial Image 1. Courthouse site on 10 August 2005

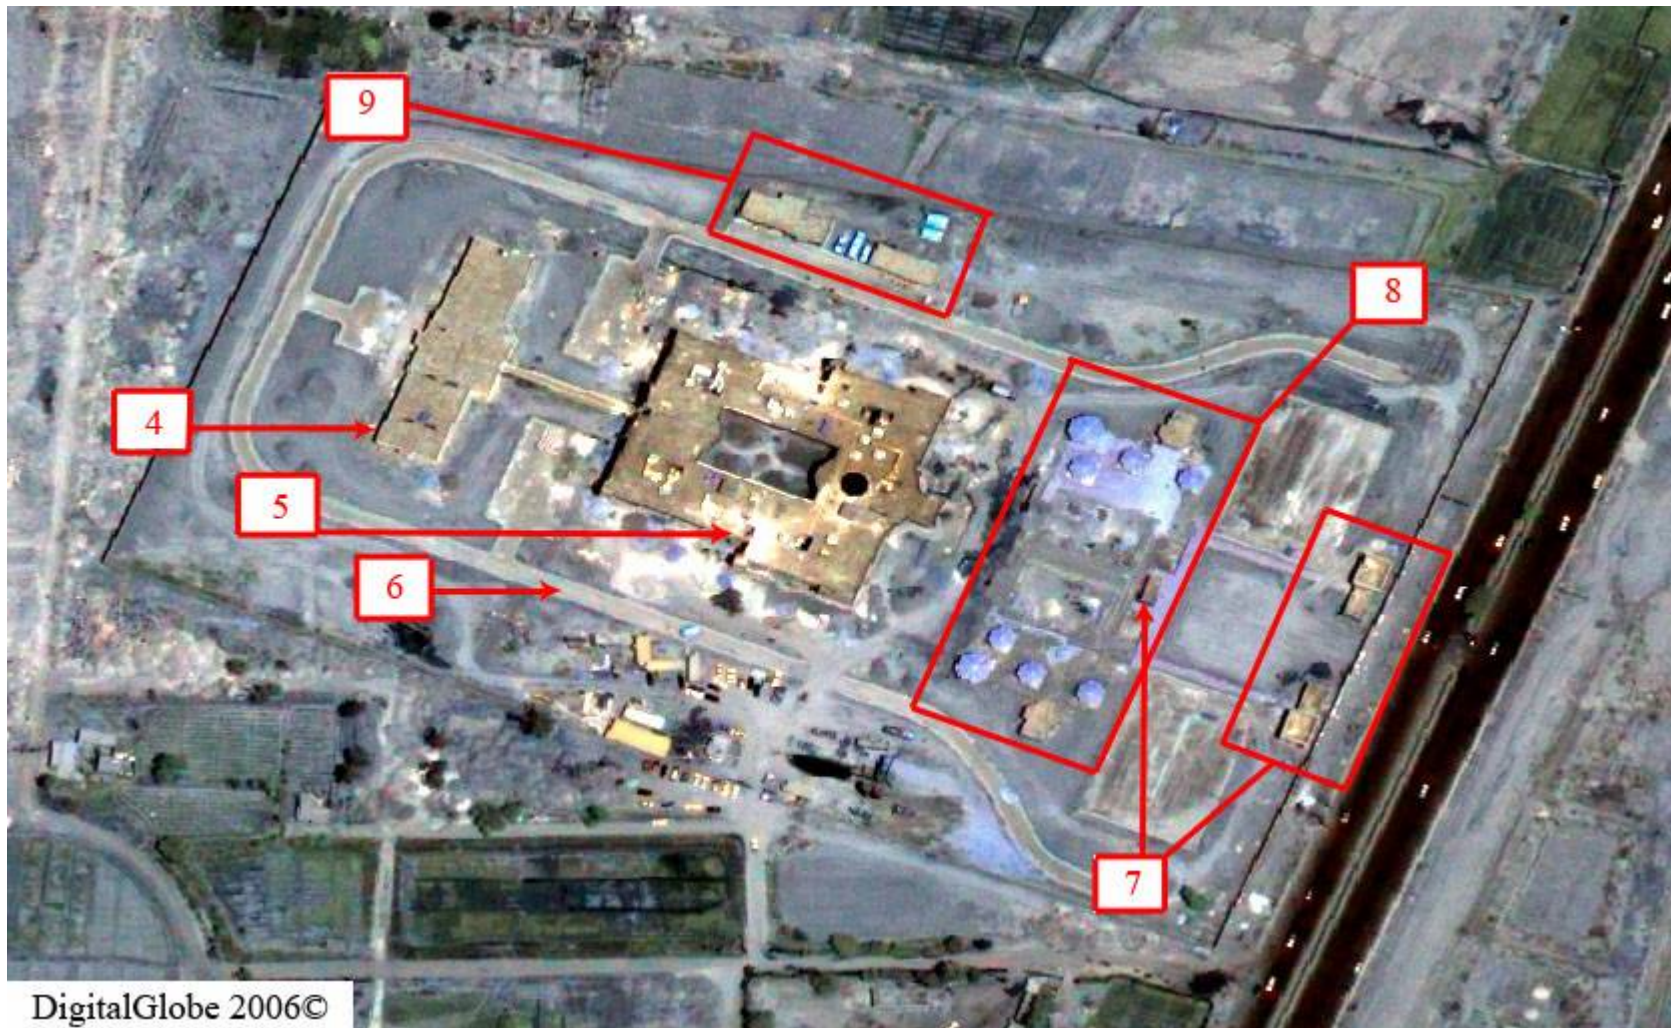
Aerial Image 2 shows the courthouse site on 16 May 2006. Item 4 shows the Annex building nearing completion. Item 5 is the substantially completed courthouse. Item 6 is the perimeter road including curb and gutter. Item 7 points to the two administrative checkpoints at the entrances and the public checkpoint within the compound. Item 8 depicts the two sets of kiosks, cafeterias, and bathroom buildings flanking the front side of the courthouse. Item 9 highlights the electrical transformer building, generators, and maintenance/water storage building.

Aerial Image 2. Courthouse on 16 May 2006
